Adelaide Park Lands Authority

## Botanic Creek Rehabilitation

How works in Botanic Creek (Park 13 to Park 16) will improve watercourse stability, biodiversity and water quality.

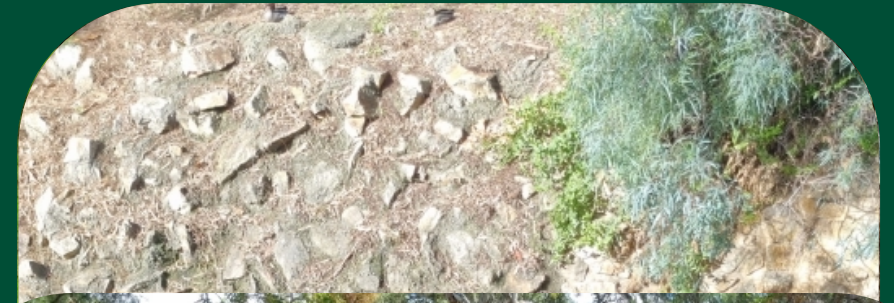
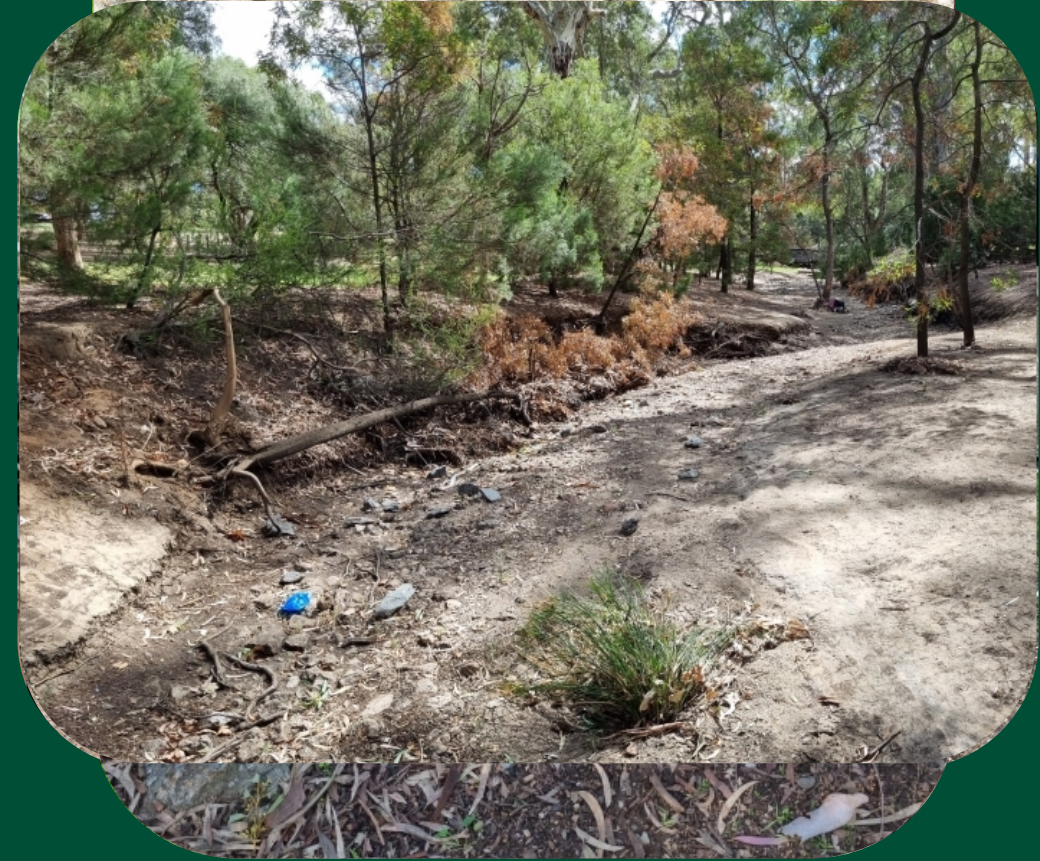
*Images: King Rodney Park / Ityamai-itpina / Park 15*

- Erosion leading to sediment mobilisation and undermining riparian vegetation.
- Erosion noted at several locations through King Rodney Park / Ityamai-itpina (Park 15) with the greatest extent of open channel.
  - Scour at outlet from culvert under Wakefield Road
  - Erosion and bed deepening
  - Several local bank erosion points undermining vegetation
  - Scouring along and downstream of horse jump near existing bridge

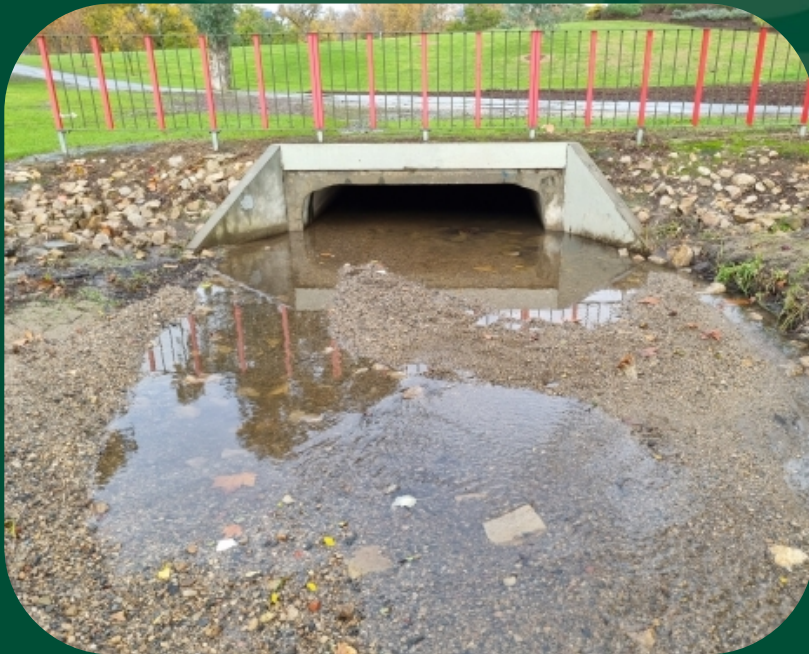
Slide 7 Rymill Park / Murlawirrapuka / Park 14

- Sediment diverting low flows towards toe of banks leading to scour and reducing drainage capacity.
- Botanic Creek in Rymill Park / Murlawirrapuka (Park 14) (bottom left), downstream of Wakefield Road in King Rodney Park / Ityamai-itpina (Park 15) (bottom middle) and King Rodney Park / Ityamai-itpina (Park 15) from timber bridge (right).

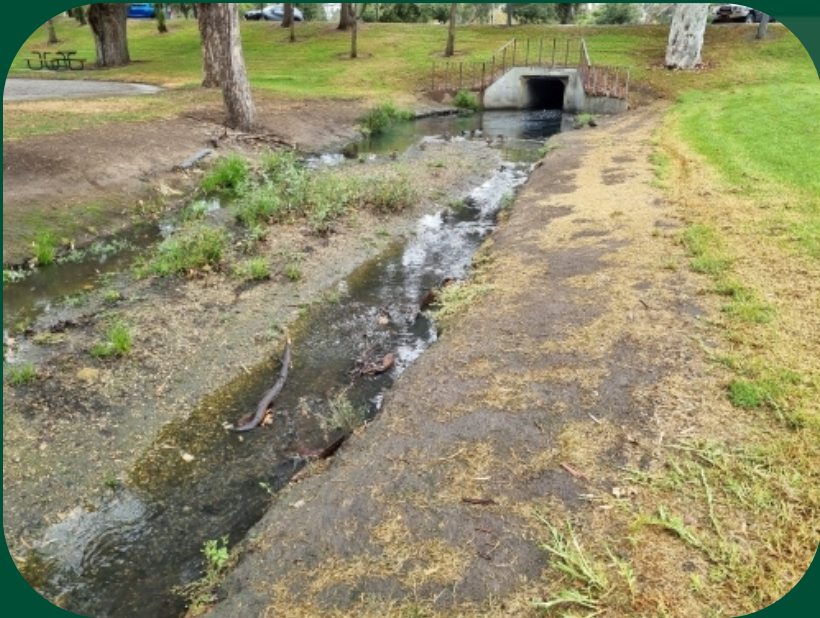
Slide 8 *King Rodney Park / Ityamai-itpina / Park 15*

- Botanic Creek current provides a poor aesthetic outcome due to a lack of vegetation in the channel bed, sedimentation (including building waste and quarry rubble) and stagnant pools in scour holes.
- Botanic Creek from bridge in Rundle Park / Kadlitpina (Park 13) (bottom left), concrete bridge in King Rodney Park / Ityamai-itpina (Park 15) (bottom middle) and Rymill Park / Murlawirrapuka (Park 14) from Rundle Road (right).

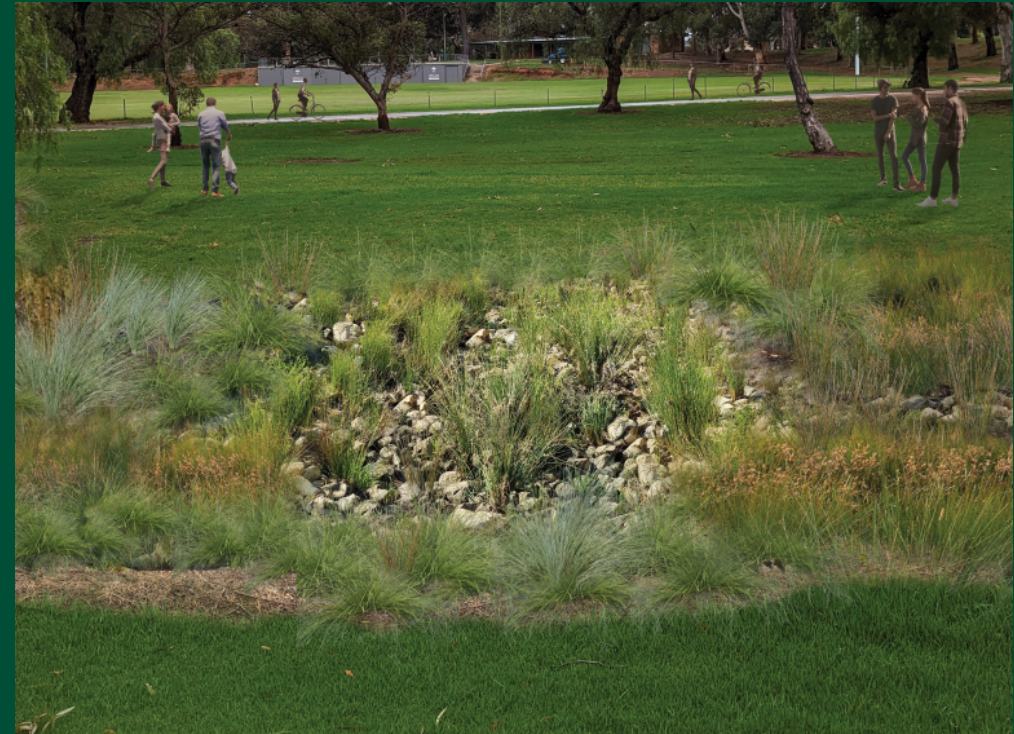
- Rehabilitation works to include:
  - Desilting – removal accumulated sediment
  - Erosion protection – rock protect erosion sites and modify jump in King Rodney Park / Ityamai-itpina (Park 15)
  - Hydraulic control structures – rock riffles in King Rodney Park / Ityamai-itpina (Park 15) to reduce velocity and weir in Victoria Park / Pakapakanthi (Park 16) to reduce flow rates
  - Revegetation – plant riparian zone with native species to improve amenity, water quality and biodiversity
  - Tree protection – minimise impact on existing trees.

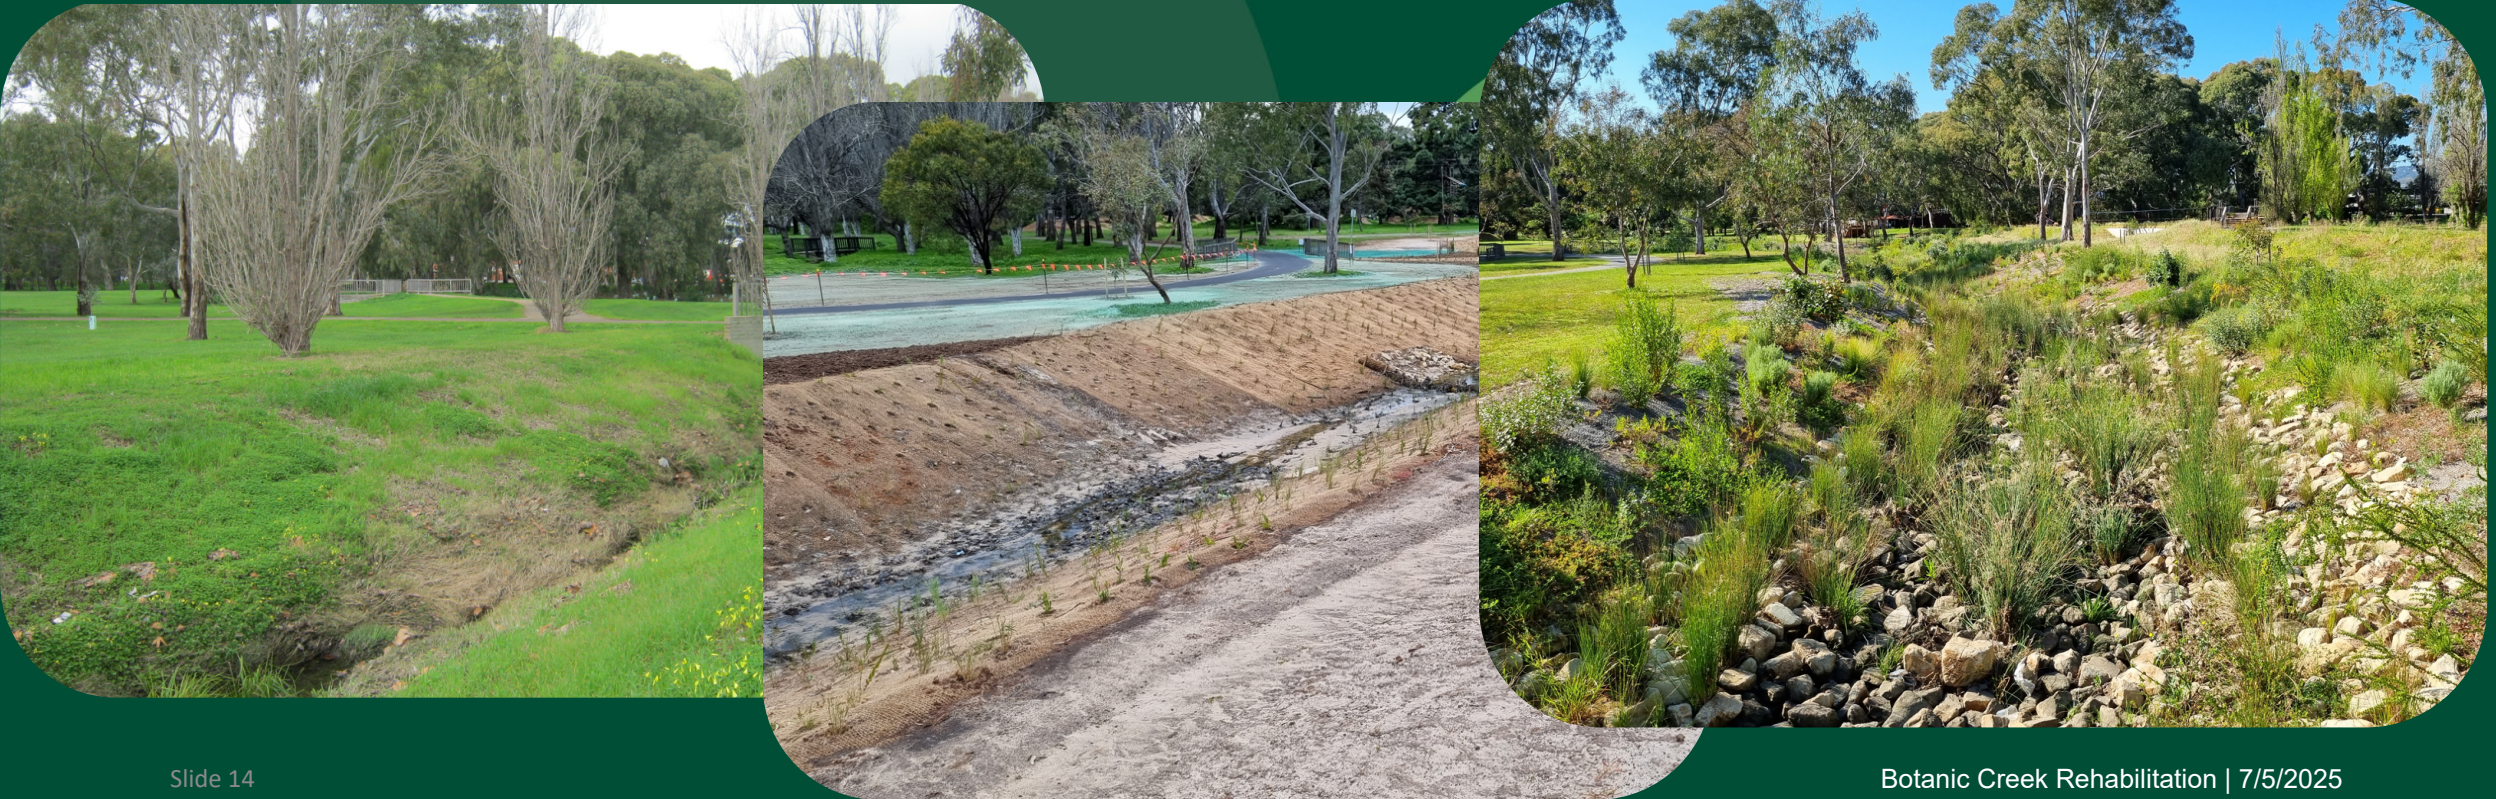
# Park Lands Creek Watercourse Rehabilitation

- Recent rehabilitation of Park Lands Creek in Blue Gum Park / Kurangga (Park 20)
